**PAPER NO. 01-2261**

**EVALUATION OF SPEED DISPLAYS AND RUMBLE STRIPS  
AT RURAL MAINTENANCE WORK ZONES**

Paper prepared for the 80<sup>th</sup> Annual Meeting of the  
Transportation Research Board  
Washington, D.C.,  
January 7-11, 2001

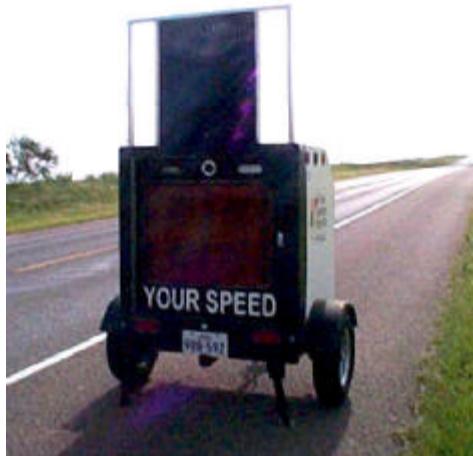
**FIGURE 1** Speed display

This evaluation utilized a SPEEDGUARD trailer-mounted speed display provided by TxDOT. Figure 1 shows the speed display used in this evaluation. The SPEEDGUARD features a 61.0 cm (24-inch) LED display and uses Ka-band radar to detect oncoming vehicles. The display has a strobe lamp that flashes when a vehicle is detected traveling over a preset speed threshold. This feature is intended to simulate the operation of photo radar, possibly decreasing speeds through the threat of automated enforcement. During this evaluation, the speed threshold for the strobe light was set at 120.7 km/h (75 mph). The display also has a 130 dB siren that can be activated by vehicles traveling over a preset speed. This option is intended to warn workers when an extremely high-speed vehicle is approaching, but was not used in this evaluation due to concerns about battery drain.

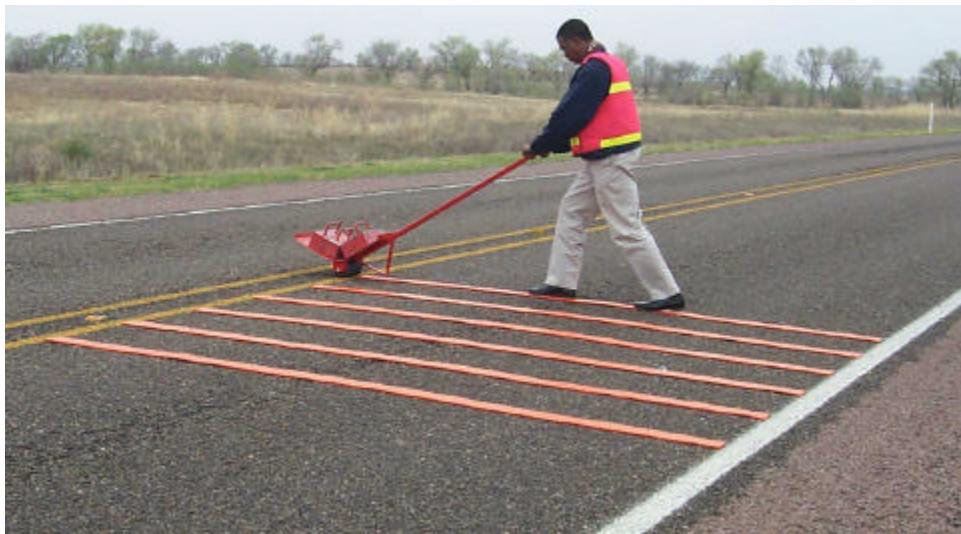
**FIGURE 2 Rumble strip installation**

The portable rumble strips tested were manufactured by Advanced Traffic Markings. The rumble strips were shipped as pre-cut 3.7 m (12 feet) long rolls. Each strip was 10 cm (4 inches) wide and 0.32 cm (1/8 inch) thick. The rumble strips were orange in color, and were applied to the pavement by removing the protective back and adhering the strips to the pavement. Six individual strips were used at each location rumble strips were placed in the work zone. These strips were placed 45.7 cm (18 inches) from one another. A weighted tamping cart or roller can be used to better attach the strips to the pavement. Figure 2 shows the application of the strips to the pavement. For this study, 0.64 cm (1/4 inch) thick rumble strips were created by applying rumble strips to each other.

Installation and removal of the rumble strips was more complicated than for the speed display. The rumble strips were firmly applied to the pavement using a tamping cart at 45.7 cm (18 inch) intervals. The strips were applied to a dry road in 32 °C (90°F) temperatures. The adhesive immediately bonded to the road, and the strips remained firmly attached to the road throughout the data collection. It took three workers about 20 minutes to install each set of rumble strips, yielding a total installation time of approximately 40 minutes for both sets. After data collection was completed, the rumble strips were removed from the road by grabbing a corner of the strip and peeling it from the pavement. The strips were not reusable.
