Guidelines

on
Ensuring
Positive
Guidance
in Work Zones

This document describes challenges and countermeasures in the provision of positive guidance for motorists in a work zone. The document presents recommended practices and effective strategies and techniques that can be used during the planning and construction phases to ensure positive guidance.

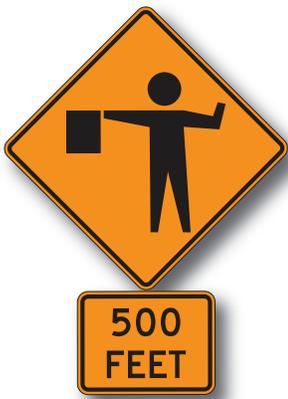
One of the more common situations where positive guidance principles are violated is in leaving signs up or uncovered when they are no longer needed. An example of this is when a work crew stops for the day but the traffic control signing for that operation (e.g., Flagger Ahead, Left or Right Lane Closed Ahead, etc.) is left in place. In some states, temporary reduced work zone speed limits are established when workers are present, and may be incorrectly left up when the work shift is over. This situation also often occurs when signing for a temporary hazard (e.g., Bumps, Grooved Pavement, or No Center Line) remains installed after that condition no longer applies. Each of these situations reduces driver confidence that the signs are presenting accurate information, and thus reduces the overall credibility of the temporary traffic control system.

A drive-through site inspection at the end of each work shift is one of the easiest ways to reduce the frequency of this type of positive guidance violation. A quick assessment of the appropriateness of each sign should be made. For certain signs initially installed throughout the work zone on long-term supports, (e.g., No Center Line or Grooved Pavement signs), it may be possible to cover some when work has already been completed and the specified hazard no longer exists.

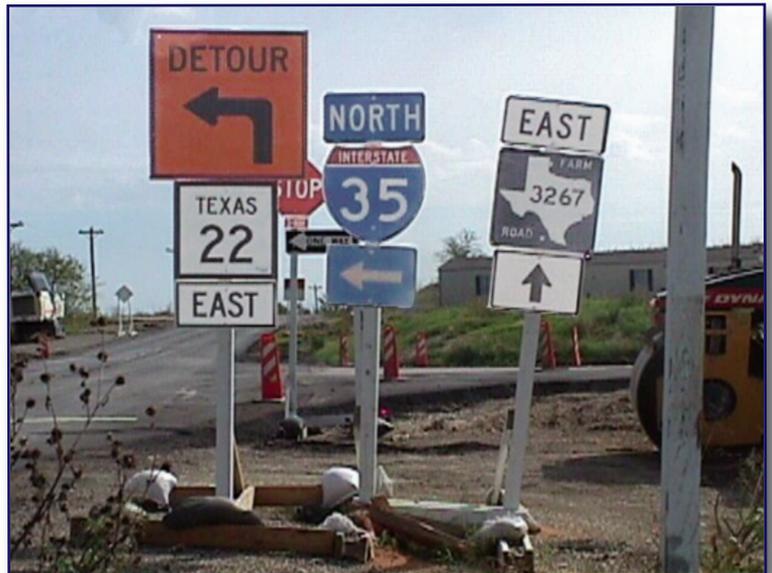
The most common situation where such interactions occur is when work zone signs are placed adjacent to or immediately upstream or downstream from static signs (either overhead or side-mounted). If static signs are mounted on the roadside, temporary work zone signing placed too close in front of or behind the existing sign will obscure one or more other signs. As a result, operational and safety problems can then occur. Depending on the amount of existing sign information already present at a location, the addition of a temporary traffic control sign can exceed driver information processing capabilities at that point, and can result in drivers missing key information from one of the signs. Drivers may slow down dramatically to allow additional time to read the signs (which creates speed differentials among vehicles) or fail to take appropriate driving actions because they missed key information or were confused as to the correct action to take.

Both types of signing challenges can be avoided by striving to maintain sufficient distances between all signs (both existing and temporary traffic control) that are located in the work zone to allow adequate information processing time for drivers. When considering the spacing between signs, the sequence of messages that end up being deployed in the field should be reviewed to ensure that an incorrect message is not implied to drivers. As shown in the photo, a Left Lane Closed sign for a downstream temporary lane closure that is positioned just upstream of an End Road Work sign for an upstream work zone could be incorrectly interpreted as a very short work zone.

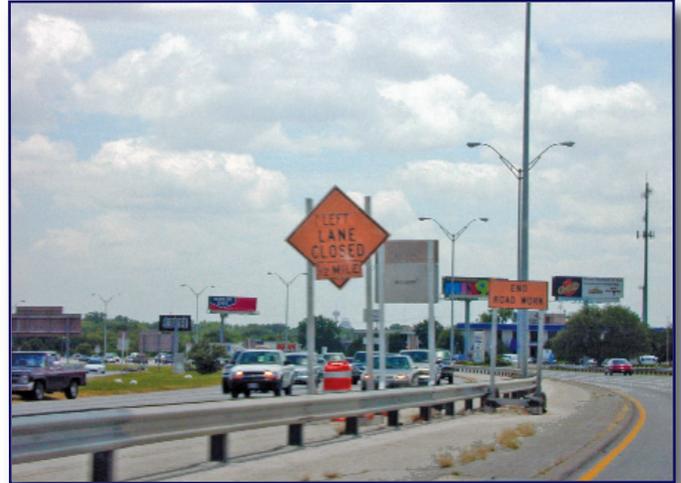
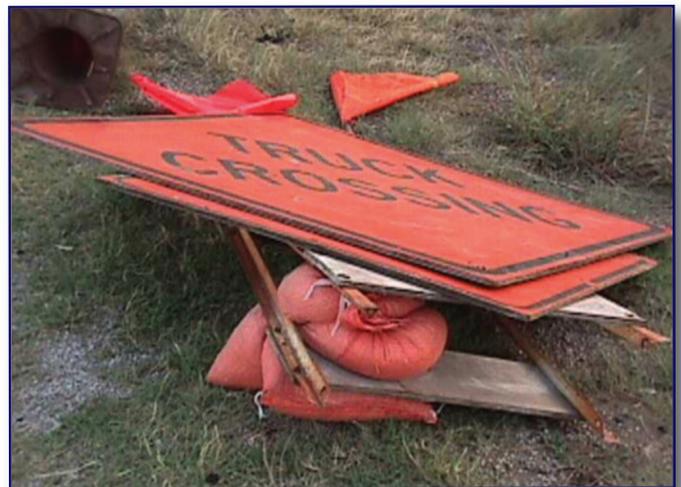
A third challenge to signing as positive guidance is the use of signs beyond their useful service lives. Unlike permanently-installed highway signs, work zone signs are often subjected to fairly harsh conditions, especially if they are used repeatedly. Storage and retrieval techniques such as throwing signs on the top of one another can put significant wear and tear on a sign, particularly the sheeting material. Cuts, tears, and stains on the sheeting can make the symbol or text illegible from required reading distances.

Further, damage to the sheeting material can destroy its retroreflective properties, which are essential for legibility under nighttime viewing conditions.

Federal regulations (23 CFR 630.1110) require agencies to develop and implement quality guidelines to help maintain the quality and adequacy of the temporary traffic control devices for the duration of the project. The national MUTCD also requires agencies to maintain signs, including work zone signs that will be in place during nighttime hours, at minimum levels of retroreflectivity. Finally, work zone conditions often stir up dirt and road grime that quickly accumulate on a sign face, reducing retroreflectivity and legibility below acceptable levels.

Challenges in maintaining work zone sign legibility can best be met by employing one or more of the sign management methods outlined in Section 2A.08 of the MUTCD. Regular visual nighttime inspections of work zones is a common way many agencies ensure that signs are adequately legible and retroreflective, although inspectors may need to be trained as to the proper levels of retroreflectivity that are required. Sign retroreflectivity can actually be measured in the field, but specialized equipment and personnel trained in its use

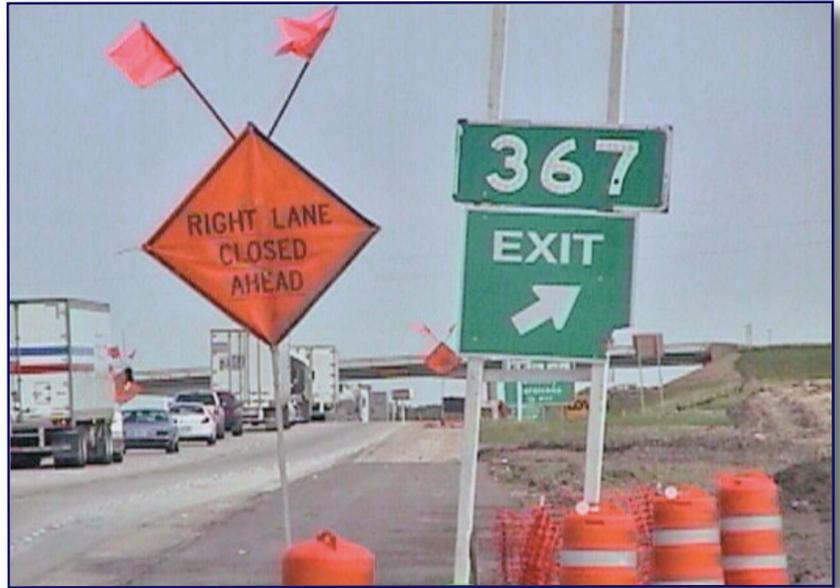
The extensive amount of utility, maintenance, and construction activity on roads in most regions means that travelers see many work zone signs. Over time, travelers can become desensitized to work zone signing and miss key information. Warning flags or lights are used on signs to increase the conspicuity of the sign and thereby raise driver awareness of important information. Warning lights are also sometimes used on channelizing devices and barricades to call additional attention to them during nighttime hours. Increasing the conspicuity of work zone signs by flags or flashing lights reduces the likelihood that the signs will be overlooked by drivers. This can be especially important in both high and low driver workload environments. Flags and warning lights both draw attention through the sense of movement that is detected visually and attracts the driver's attention.

One concern with the use of flags or flashing lights is that they can be overused within a work area (i.e., used for non-critical information). Also, the implementation of these devices increase the maintenance requirements in that periodically the lights must be checked and flags replaced when tattered and/or faded. Care should be taken to use warning flags and signs only when necessary to increase driver awareness of highly critical warning information that, if missed, could significantly reduce safety at that location. To manage usage, some agencies will allow or require warning lights or flags on the first sign encountered when entering a work zone, and not use them on the remaining signs in the work zone. The intent of this practice is to maximize the probability that motorists observe the first sign, recognize that they are entering a work zone, and pay additional attention to the work zone signs that follow to warn of hazards and guide them through the work zone.

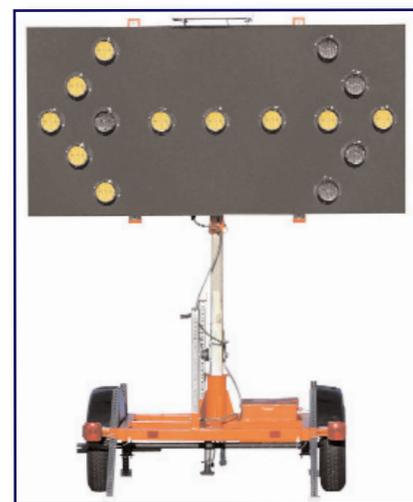
The national MUTCD allows an arrow board to display a flashing arrow, sequential arrow, or sequential chevron to indicate that a lane is closed to traffic (a flashing double arrow can be used on mobile operations or at lane splits to tell drivers to merge left or right). Many arrow boards use a set number of pixels to create these arrows/chevrons. Although an arrow board is readily legible and recognizable from a significant distance when all pixels are performing properly, the loss of a few critical pixels can seriously reduce legibility.

Repair of malfunctioning pixels is the obvious countermeasure to address this type of positive guidance challenge. Arrow boards should be visually inspected from a significant distance upstream because pixels can sometimes shake out of alignment and appear to be lit up close but not be visible at a distance. Regular visual inspections during different times of the day can also identify whether orientation of the arrow board relative to the sun causes a “washout” condition at certain times and obscures the arrow display. If this occurs, the board should be moved to a different location or replaced with one that has a higher luminance output (the layout of the lane closure taper would obviously have to be moved as well if the arrow board must be moved).

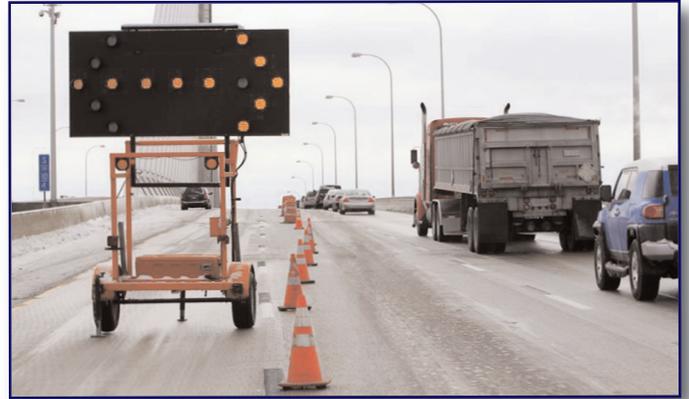
The arrow board is to be placed on the shoulder at the beginning of the merging taper. If a shoulder is not available, however, the board can be placed in the closed lane behind the channelizing devices. Care must be taken not to allow the arrow board to be placed too far downstream in the closed lane, however, as this can violate a driver’s expectancy for the merging taper to be located at or just beyond the location of the board.

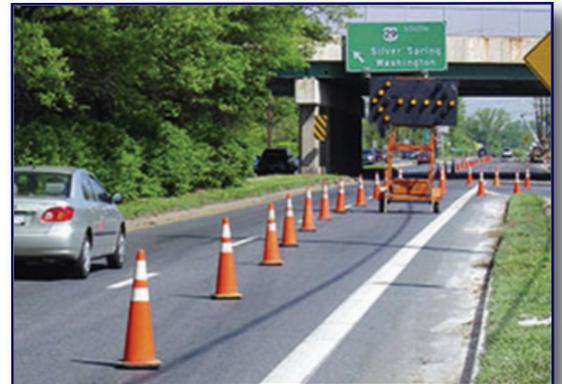
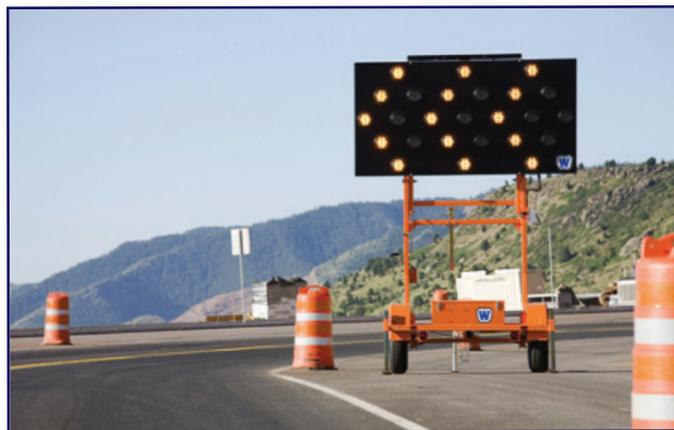
In addition to issues with the board itself or with sunlight glare, arrow board visibility and legibility can be compromised if the board is located just beyond the crest of a hill. The objective of lane closure taper and arrow board placement is to ensure enough visibility to provide decision sight distance. At normal highway speeds (i.e., 55 to 70 mph), the arrow boards should be positioned so that they are visible from at least 900 and 1,500 feet upstream. Further, arrow boards are to be designed so that they are legible from ½ mile, or 2,640 feet, away.

Cross-street overpasses, pedestrian bridges, and overhead sign structures can also obstruct visibility of the arrow board. In most cases, this issue can be solved by simply extending the lane closure upstream to the top of the hill or before the features that are causing the sight obstruction. On urban freeway sections that are depressed below grade through downtown areas, this may mean extending the lane closure upstream several hundred feet until adequate sight

Sight distance to arrow boards can also be restricted by horizontal curves and should be relocated when such sight distance restrictions are present. However, even when adequate sight distance is available, placing arrow boards on horizontal curves creates additional positive guidance challenges to motorists because the curvature of the roadway makes it difficult for motorists to interpret easily if it is their lane that is being closed (since

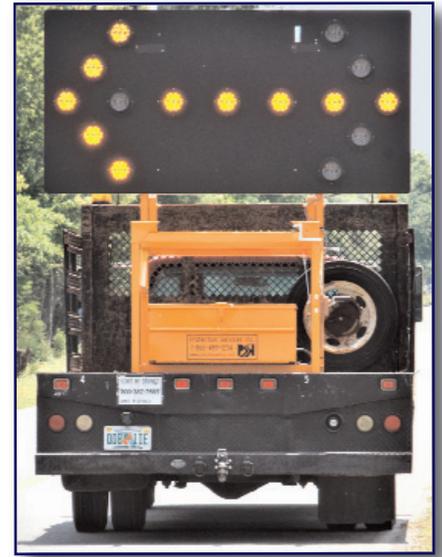
Locating arrow boards at entrance or exit ramps presents another positive guidance challenge. When the board is positioned at an exit ramp, motorists can become confused into thinking that they should take the exit as part of the traffic control plan (for a left lane closure adjacent to a right-handed exit ramp), or that the ramp itself is closed when it is not (for a right lane closure just beyond a right-handed exit ramp). When placed adjacent to entrance ramps, the arrow board competes for driver attention at the same spot where vehicles are attempting to enter the roadway. Depending on the volume of entering ramp traffic, such a situation can create an information overload condition for drivers. Moving the lane closure taper and arrow board upstream before the entrance ramp allows drivers to concentrate on one activity at a time (first to move out of the closed lane, then to accommodate traffic entering the roadway).

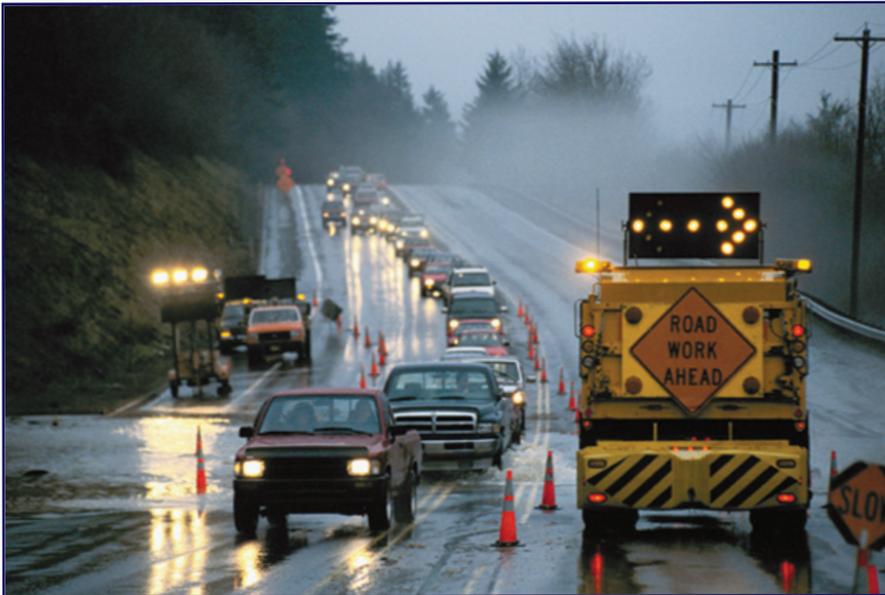
The final type of positive guidance challenge occurs during mobile work operations rather than stationary lane closures. When a work convoy is moving along the shoulder of a roadway performing maintenance or other activity, the arrow board on the upstream shadow vehicle is to display a caution message rather than an arrow, as drivers are not being told to exit a lane. However, many roadway shoulders are discontinuous such as across long bridge spans. When a work convoy reaches these locations, it must move into an active travel lane, and

then move back to the shoulder once across. Vehicle operators will sometimes forget to switch from the caution display to an arrow display when moving into the travel lane, and/or back to the caution mode once moving back to the shoulder.

Remembering to switch between display modes is one of the many issues that shadow vehicle operators traveling in a convoy must attend to while working. Making sure the issue is brought up during initial training is key to reducing its occurrence in the field. Periodic reminders of the importance of proper arrow board displays will encourage correct procedures.

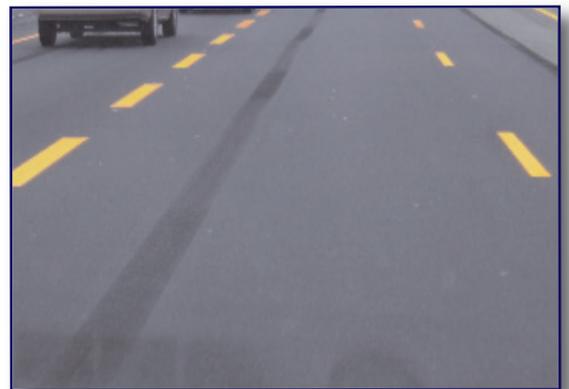
Perhaps the greatest challenge that agencies face when trying to ensure positive guidance through a work zone is the obliteration of existing pavement markings and installation and maintenance of temporary markings. When markings are removed, they are commonly ground or burned off, which leaves a scar in the shape of the existing marking. If the pavement is particularly porous, the marking material seeps into the pavement and can be very difficult to remove completely without removing a significant portion of the roadway surface. Both scarring and incompletely removed markings can be confused with newly installed markings, especially under wet nighttime viewing conditions.

Various methods have been developed through the years to reduce the scarring and incomplete removal problems associated with work zone pavement marking. Both water and sand (or other material) blasting techniques have been developed, but are expensive compared with other removal techniques. Paints that can be more easily removed with water or special solvents are under development for potential application in work zones, but as yet are not generally durable enough to withstand the environmental and traffic conditions present in most work zones. Likewise, foil-backed temporary pavement marking tapes have been developed that can be more easily removed when markings must be changed. However, these tapes can be more expensive than traditional marking materials and must be applied in warm, dry conditions in order to remain adhered.

Some agencies have found blackout tape to be an effective alternative to pavement marking removal. However, if used, blackout tape should provide — and be able to maintain — sufficient friction so as to not be a hazard to motorcyclists and bicyclists. Also, some blackout tapes can create glare in certain sun positions and appear to be a marking itself, which agencies should be aware of and on guard against. In some cases, an agency may require the contractor to cover the entire pavement surface with a thin overlay or seal coat to obliterate pavement markings each time a phase change requires a shift in travel lanes.

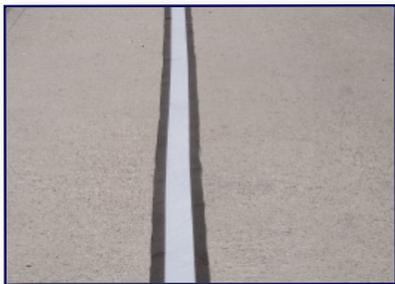
Even if scarring and incomplete pavement marking removal are not significant issues, the complexity of certain work zones can make it challenging for motorists to comprehend and safely negotiate the travel path through the work zone. In those cases, techniques are available to help increase the attention-getting and information dissemination properties of pavement markings. One technique is to use wider temporary pavement markings, especially for the edge line. Studies indicate that wider edge lines improve safety in permanent applications, and so should also improve conditions in temporary applications.

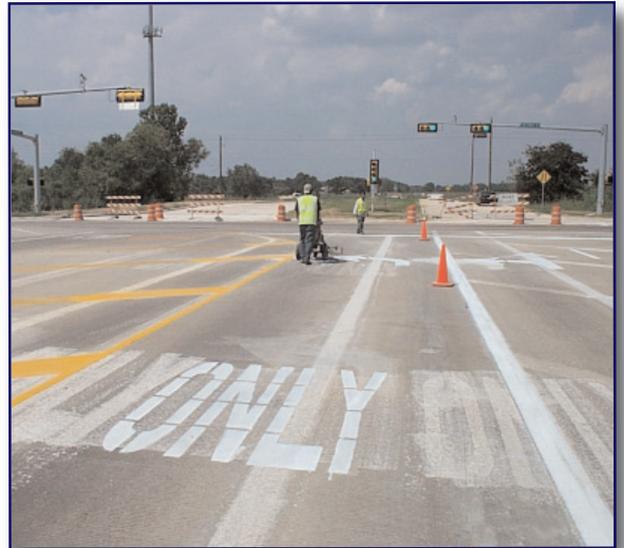
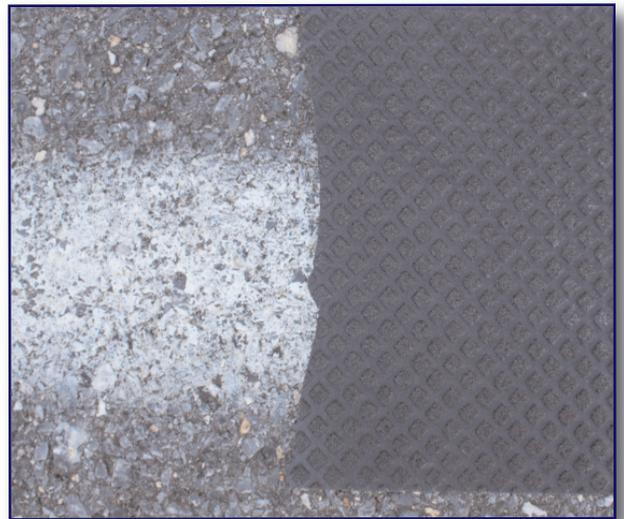
Another technique is to use contrast markings around or adjacent to the actual pavement markings to increase their conspicuity and the ability of drivers to be guided by them.

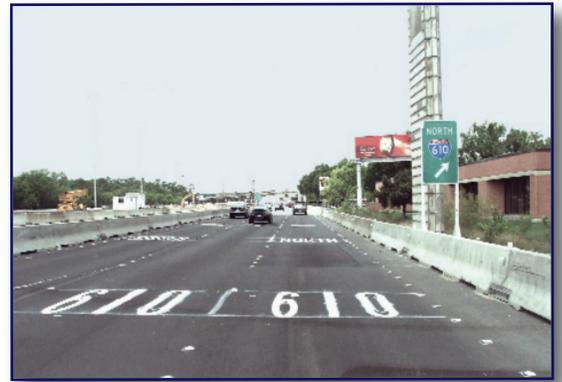
A third technique, most commonly considered in urban freeway work zone applications, is the use of in-lane markings to supplement overhead or side-mounted temporary guide signing. Freeway reconstruction activities in and around major interchanges often involve lane shifts and even lane reconfiguration from exclusive to optional exit lanes (and vice versa) as the project proceeds through its various phases. Additional guidance is needed to aid commuters in determining the appropriate lanes they should use in each phase. Both text and route shield markings can be used (although the text markings may be more common because of cost savings). These markings can have less friction than the surrounding pavement in wet-weather conditions. Consequently, they should be located on tangent sections, if possible, to reduce the chance that motorcycles leaning into a curve lose control if passing over one of these markings.

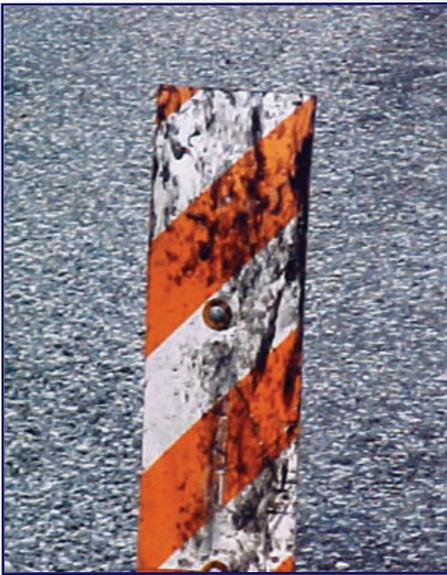
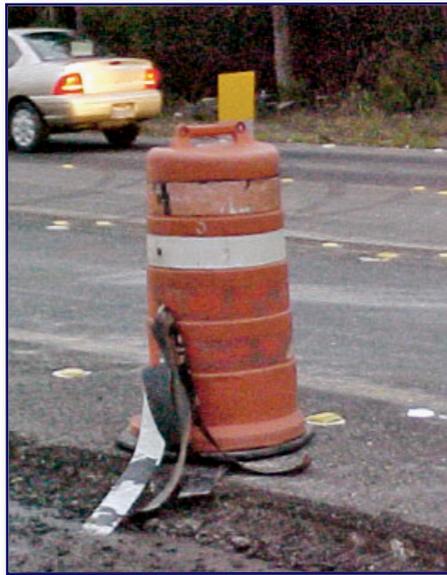
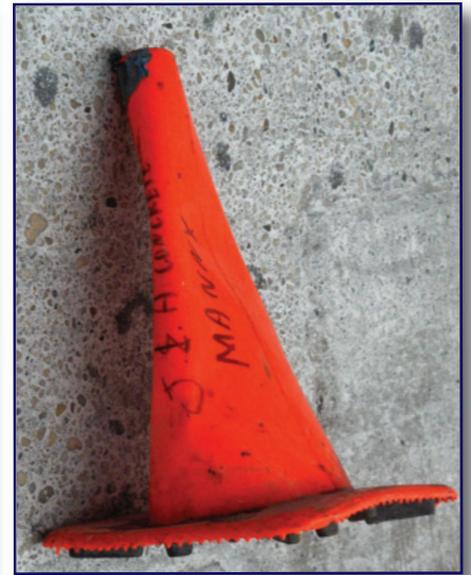
Like work zone signs and arrow boards, channelizing devices are subjected to harsh environmental, traffic, and work activity conditions that degrade the retroreflective sheeting and make them less visible to travelers. The devices are located close to the pavement surface and to both moving traffic and work vehicles which spray dirt and road grime on the devices during wet weather conditions. Also, the devices are often hit by passing vehicles (or knocked down by the vehicle draft) which can damage both the structure of the device and the sheeting attached to it. Certain work activities are extremely dirty (e.g., seal-coat or pavement overlay operations), which can coat the devices with tar or other contaminants and make them nearly invisible, especially at night.

Countermeasures to address these types of challenges are fairly straightforward. Regular inspections of work zone traffic control should occur during both daytime and nighttime viewing conditions and compared to established quality guidelines (the condition of retroreflective properties of sheeting on the devices may not be evident to inspectors during the day). The inspections may be part of the guidelines to maintain quality and adequacy of temporary traffic control devices required by the federal regulations (23 CFR 630.1110). Those devices that are damaged or covered with contaminants should be removed from service and replaced with new devices. If the contaminants are soluble, it may be possible to wash the devices and return them to a serviceable condition. However, a follow-up nighttime inspection should be performed soon after they are cleaned to verify that the devices are performing as expected.

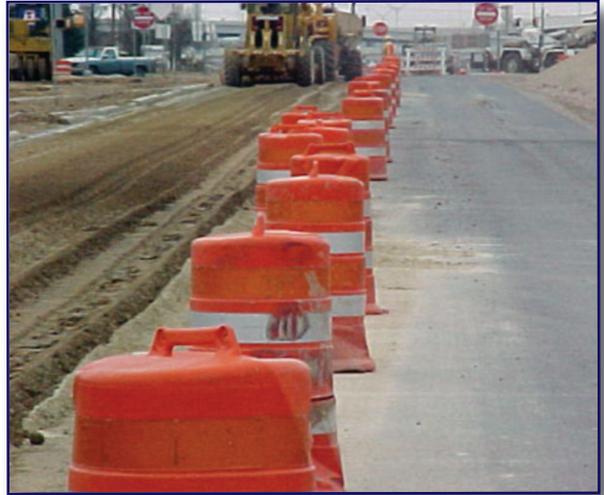
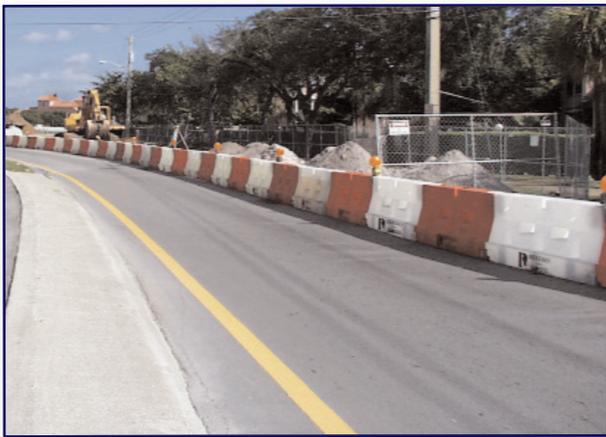
One technique to reduce the frequency of this behavior is to reduce the spacing between channelizing devices. A reduction in spacing is also believed to create more of a “wall” perception of the devices and contribute to better driver behavior. Consequently, reduced channelizing device spacing may be appropriate at work zones where destination points are closed to traffic, where traffic congestion is anticipated to develop during all or part of the day, and where workers on foot are

close to moving traffic. In extreme cases, it may be worthwhile to install longitudinal channelizing devices to eliminate completely the spaces where vehicles can try to enter the work zone. It is important to remember that these devices do not provide positive protection for workers on foot, even though the devices look similar to water-filled barriers.
